Supervision of Loading

Service number: DQC - LS - 050018

P.O Number 608125
 Product description Aprons
 Item Number OJC001/ OJC002/ OJC010/ OJC011/
 OJC015/ OJC020/ OJC026/ OJC029
 Order quantity 2,061,800
 Supplier XX XXX XX Plastic Co., Ltd
 Loading Location Ningbo, Zhejiang
 Auditors David Wong
 Inspection Date March 8th, 2005

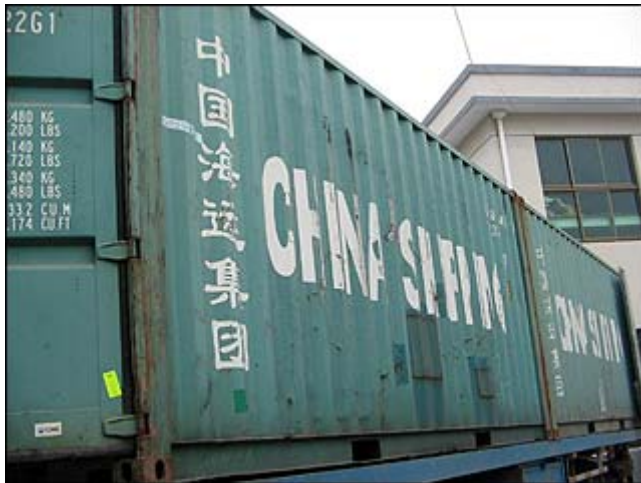
Appearance of container

1. The auditor found 12 export cartons were broken and 28 cartons were deformed, but factory had not spare cartons to replace those defective cartons and container must be delivered to warehouse at once, so factory only repaired those defective cartons.
2. Although the appearance of container was old, but it's safe, no hole was found before loading.
3. The auditor ask the workers to clean the container before loading, the result is satisfactory after the auditor double check the container again.

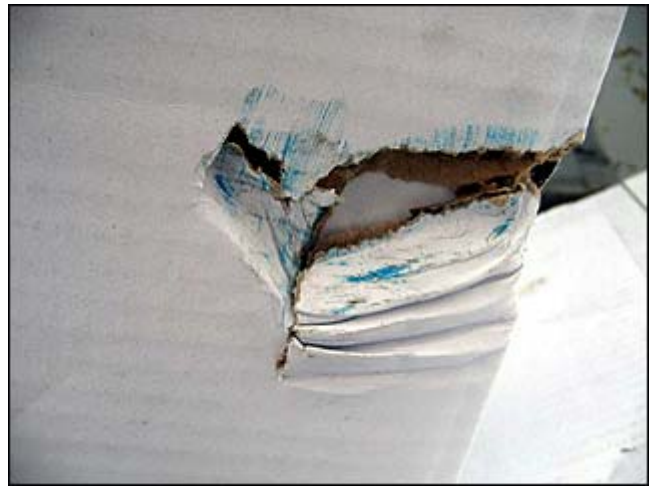
Broken carton

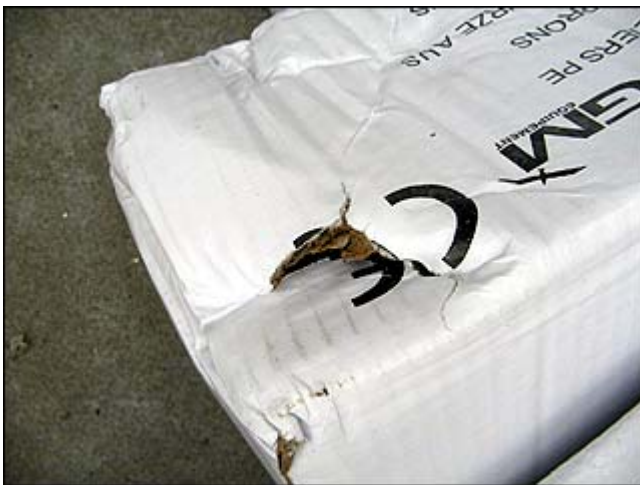
Broken carton

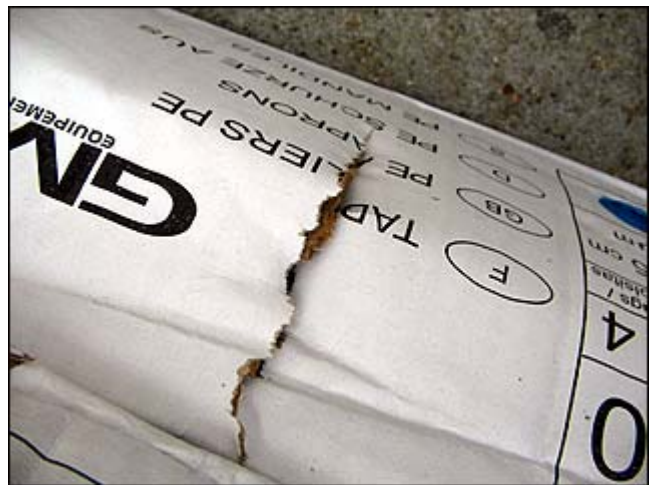
Broken carton

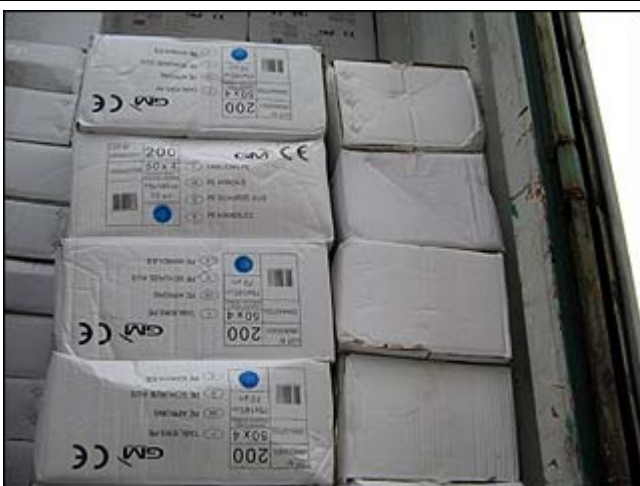
Deformed carton

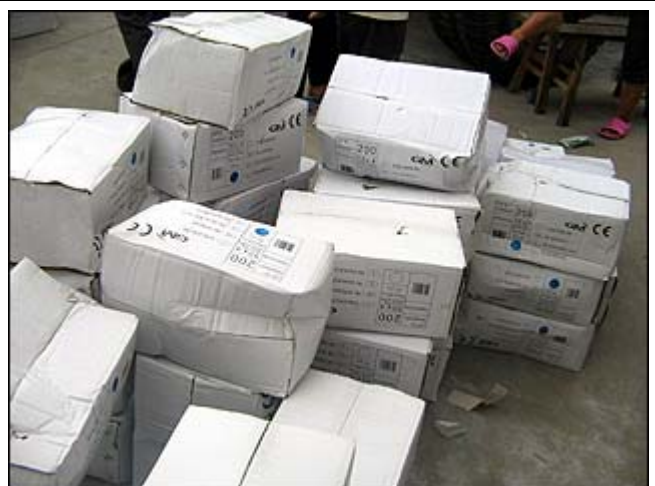
Deformed carton

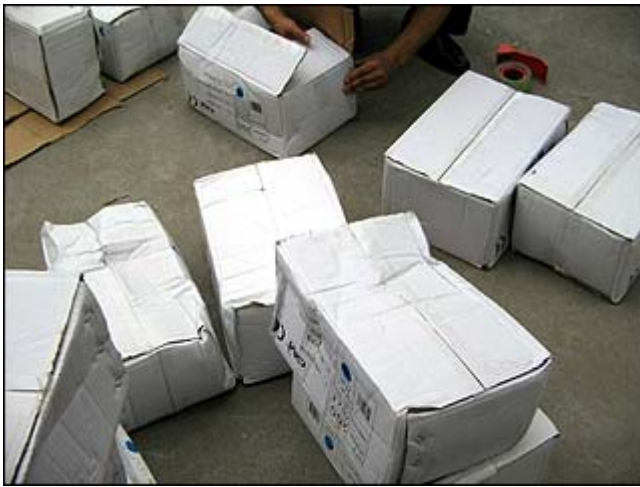
Deformed carton

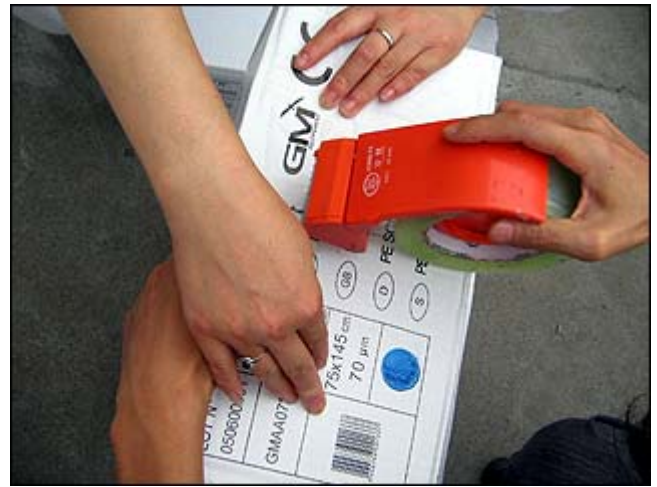
Repairing deformed and broken cartons
